Brickwork Project Planning

- Current situation with neighborhood structures
- Proposal for bridge structures
- Proposed mailbox standard

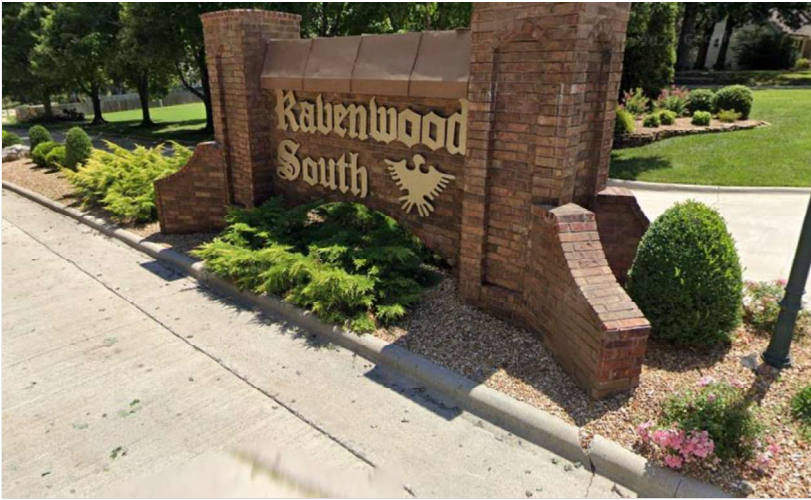
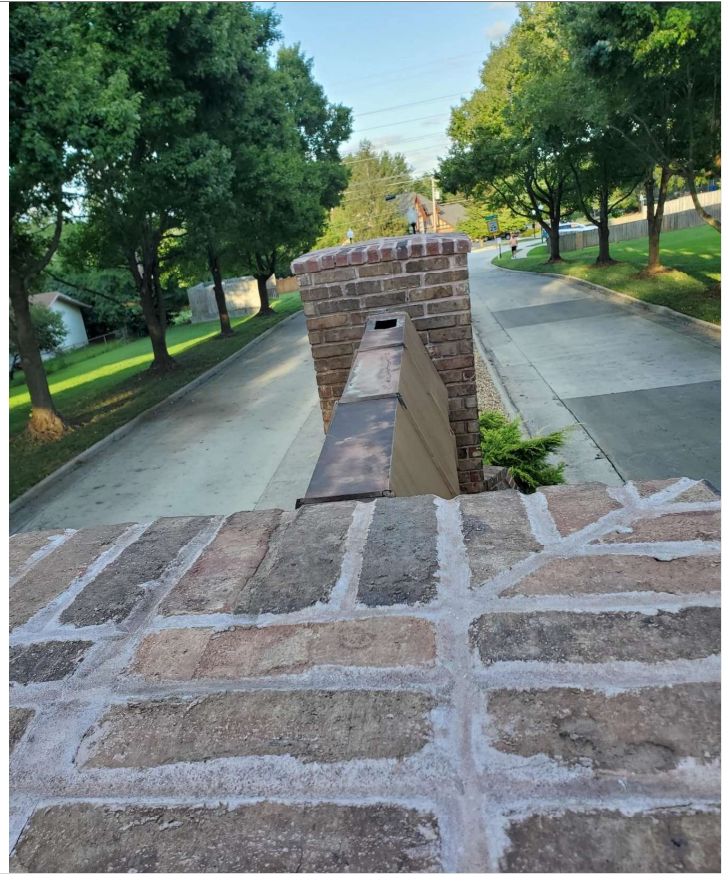
Front Sign

- Brick repair work complete – brick should last several years
- As of this fall, the top brick appears to be in good shape with new grout
- One metal panel is missing over the lighted sign
 - Rainwater and weather penetrate to interior

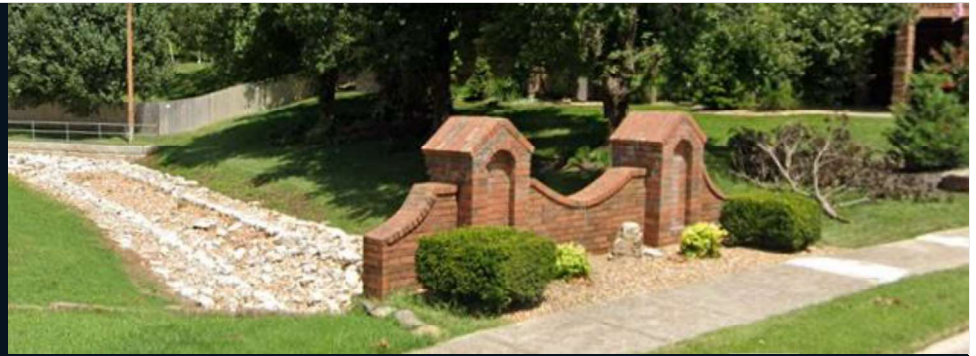
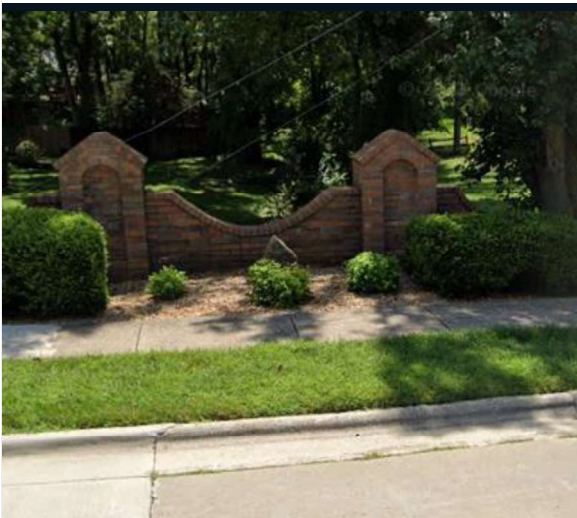
West Crossing

- Over largest drainage ditch; takes water from West side of Charleston
- North of Nottingham the ditch has been graded and rocked
- South of Nottingham / North of Lake Springfield is in poorer condition – flow is managed by berms and the ditch is not strictly maintained
- Decorative brick is failing

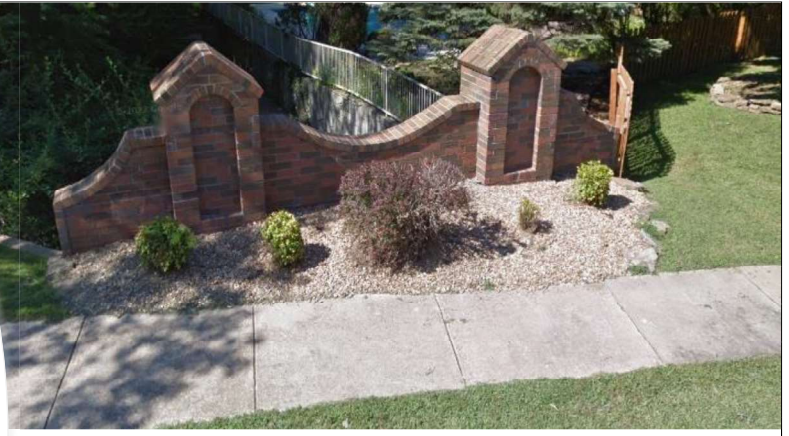
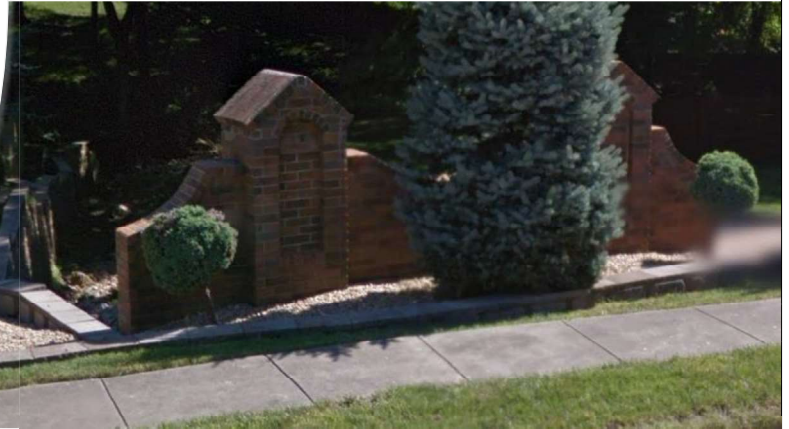
Central Crossing

- Ditch takes water from RWS and north – Lakewood, Spring Creek
- Better drainage condition upstream (north side)
- Downstream is in poorer condition but there is very little impact to RWS before Lake Springfield Park
- Individual resident solutions in place are only somewhat effective
- Decorative brick is failing

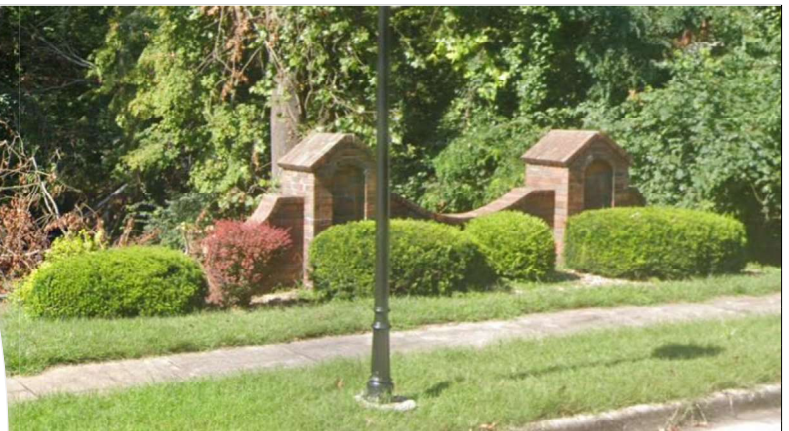
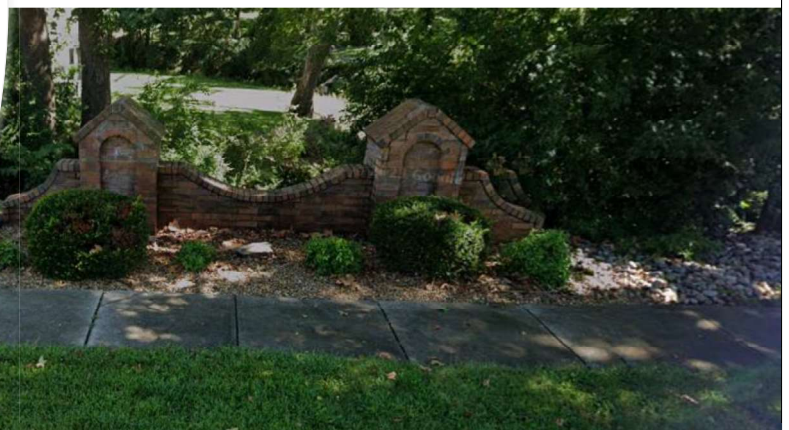
East Crossing

- Narrowest/ steepest drainage
- Significant upstream damage from rainwater flow (north side)
- Needs grading and rocking up to Norshire and even Richmond
- Individual resident solutions in place are only somewhat effective
- Decorative brick is failing

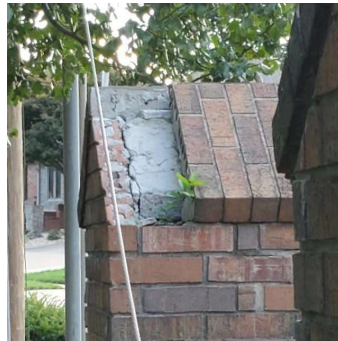
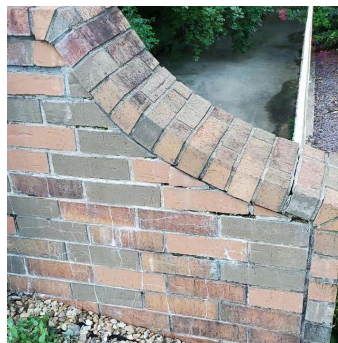
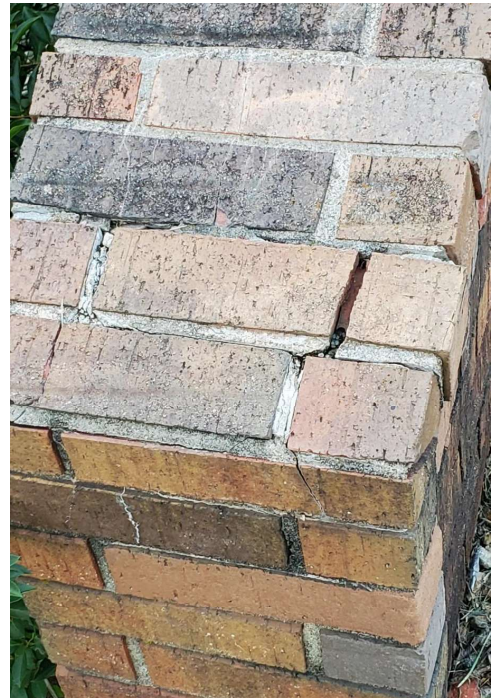
Problems with our current design

- Vertical mortar joints allow water to penetrate structure
- This is never done for a building or structure unless it is purely ornamental
- Brick walkways and patios either use pavers or are just overlays for concrete

Repairs of Brick are doable but won't last.

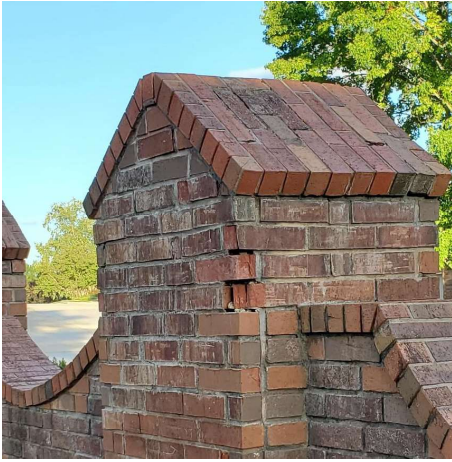
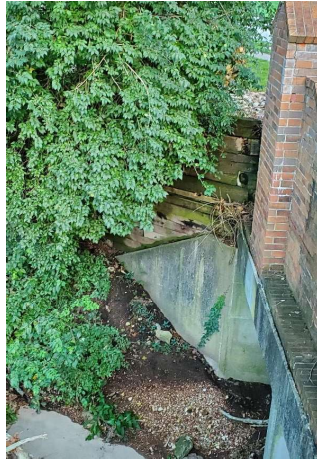
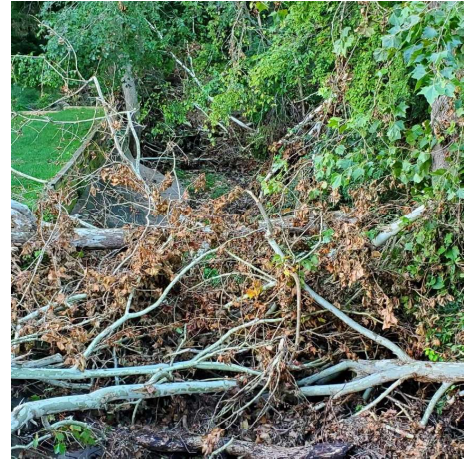
Bigger issue is drainage and ditch condition

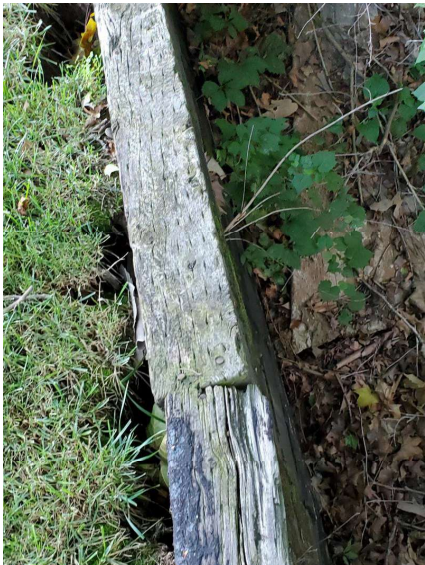
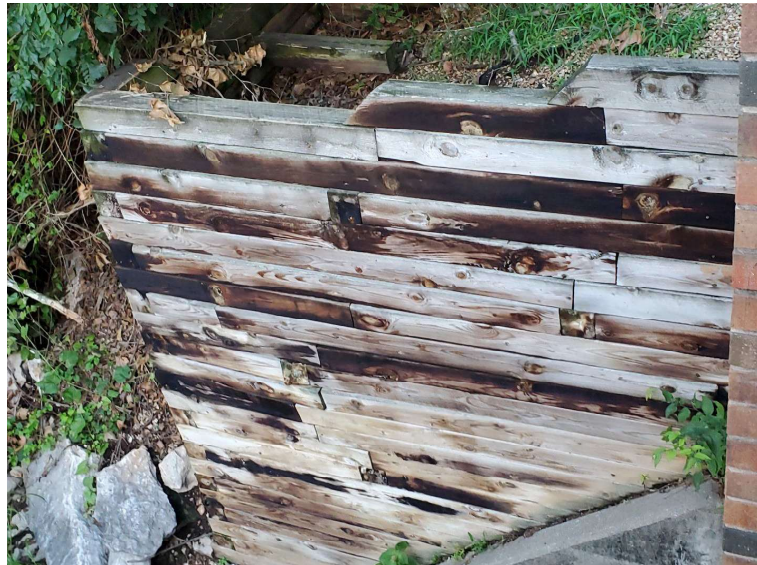
Timber retaining walls are nearing end of life; shotcrete walls also failing.
